Oregon Department of Environmental Quality

Trace Metals in Soil and Johnson Creek Sediment

October 17, 2017

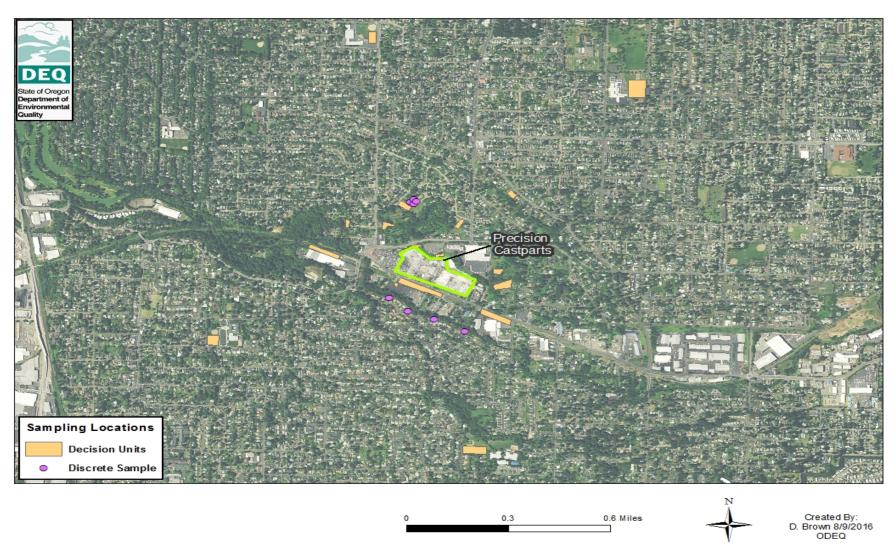
SE Portland Area-Wide Soil Sampling Locations

Sampling Locations identified in collaboration with OHA and with community input.

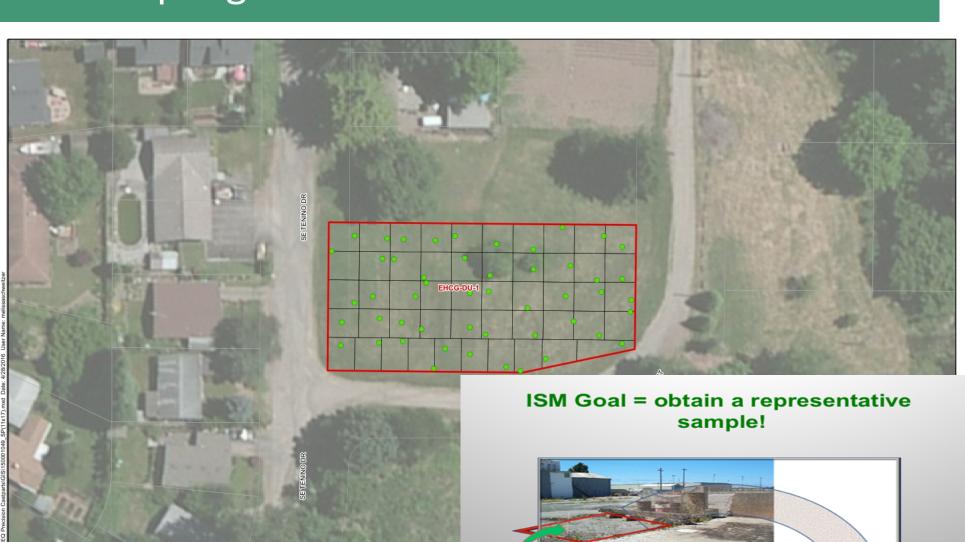
Soil Sampling Method - Incremental

- Decision Unit
- Random Sample Point
- Sampling Grid
