Johnson Creek Geologic and Geomorphic History

Nick Legg, PG
nlegg@wolfwaterresources.com

Two Goals:

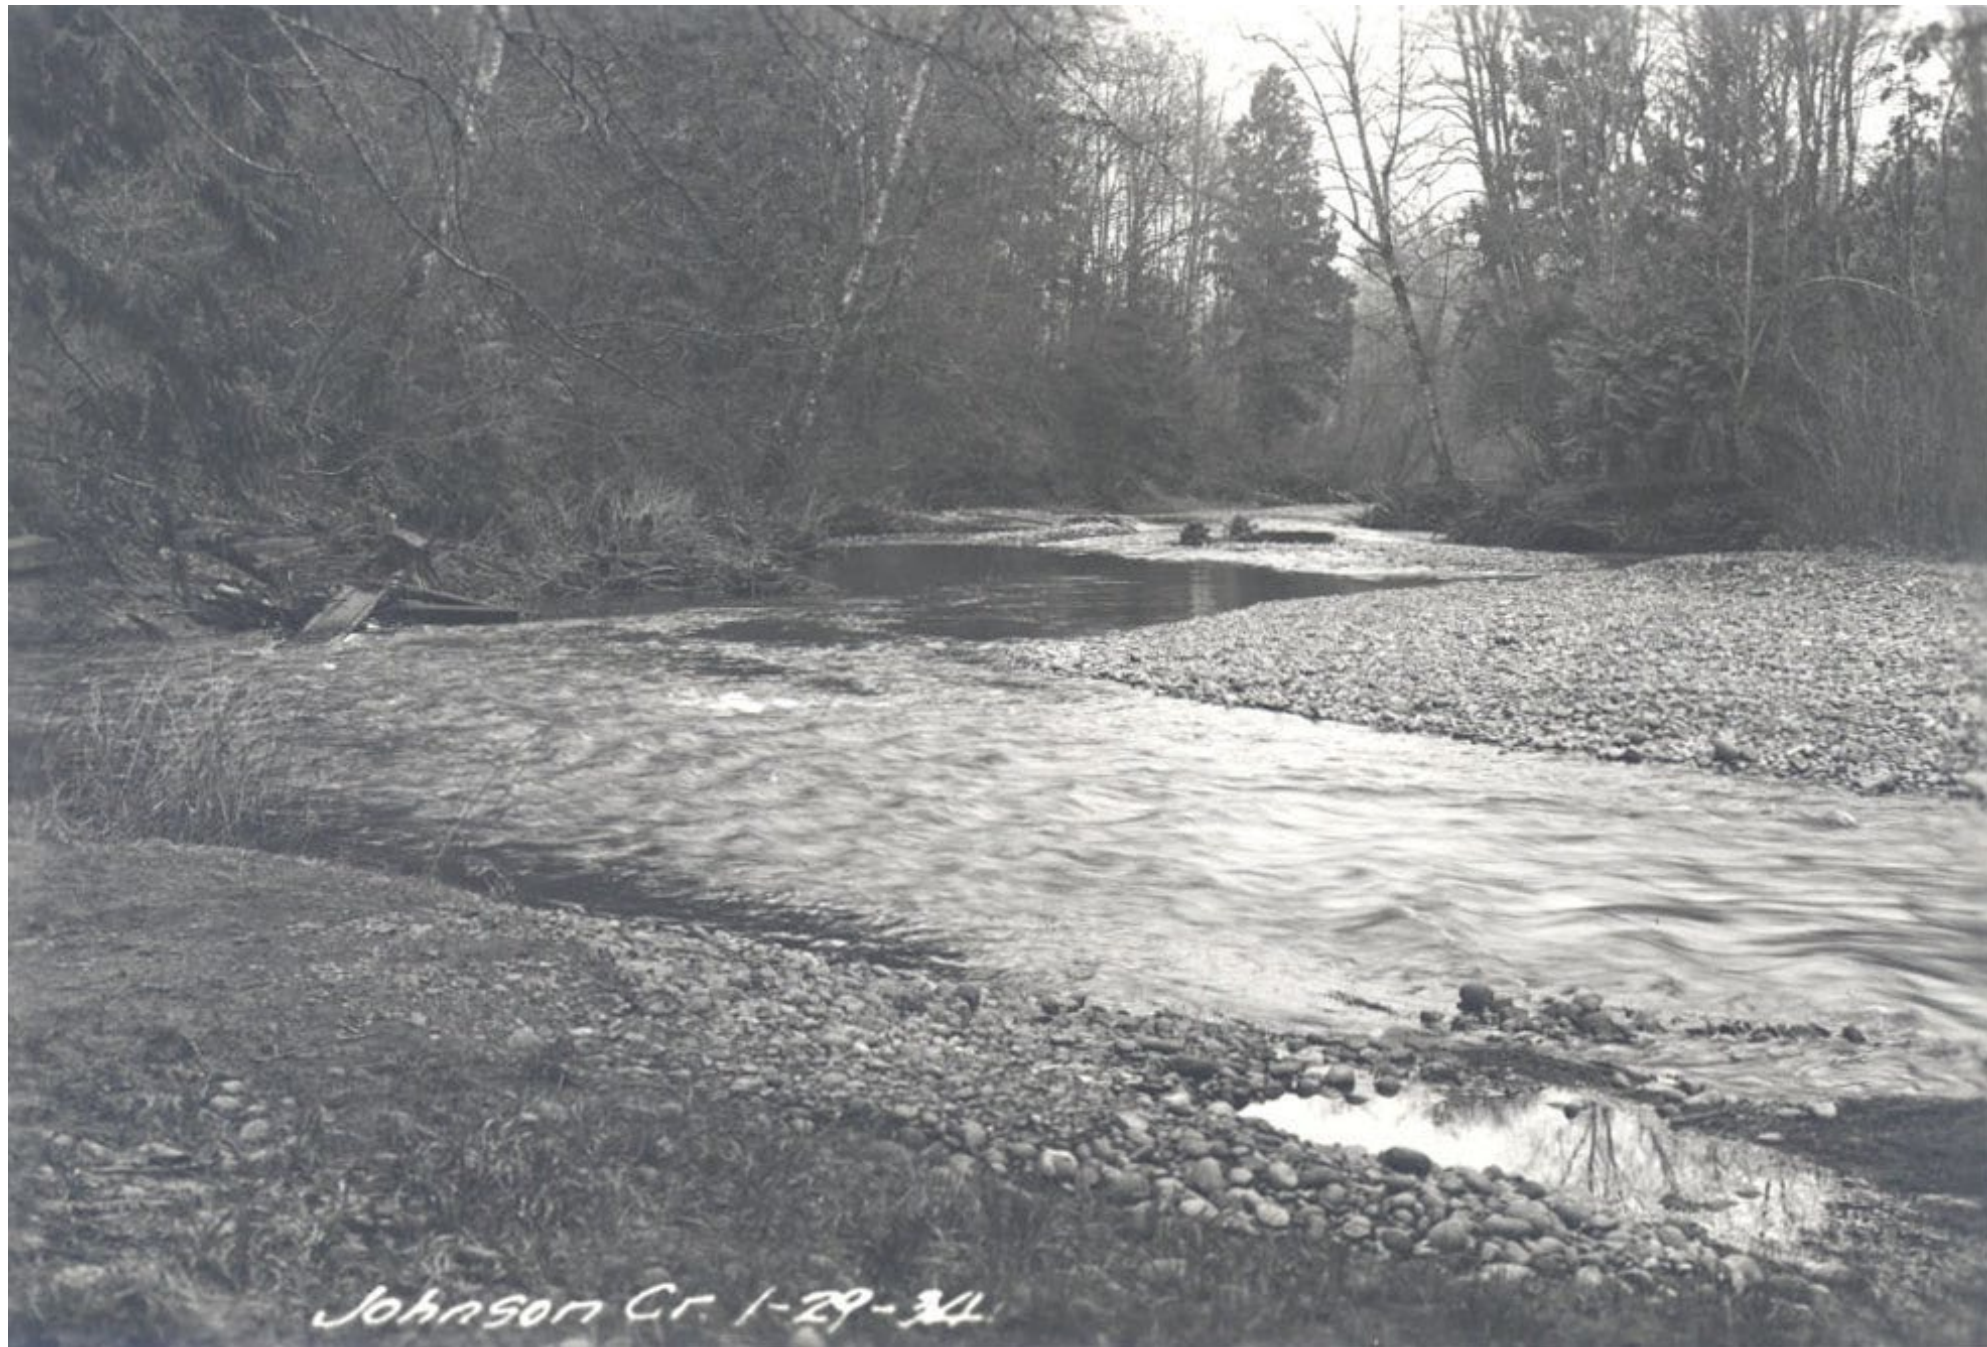
Johnson Cr. 1-29-34

How dynamic
was Johnson
Creek?

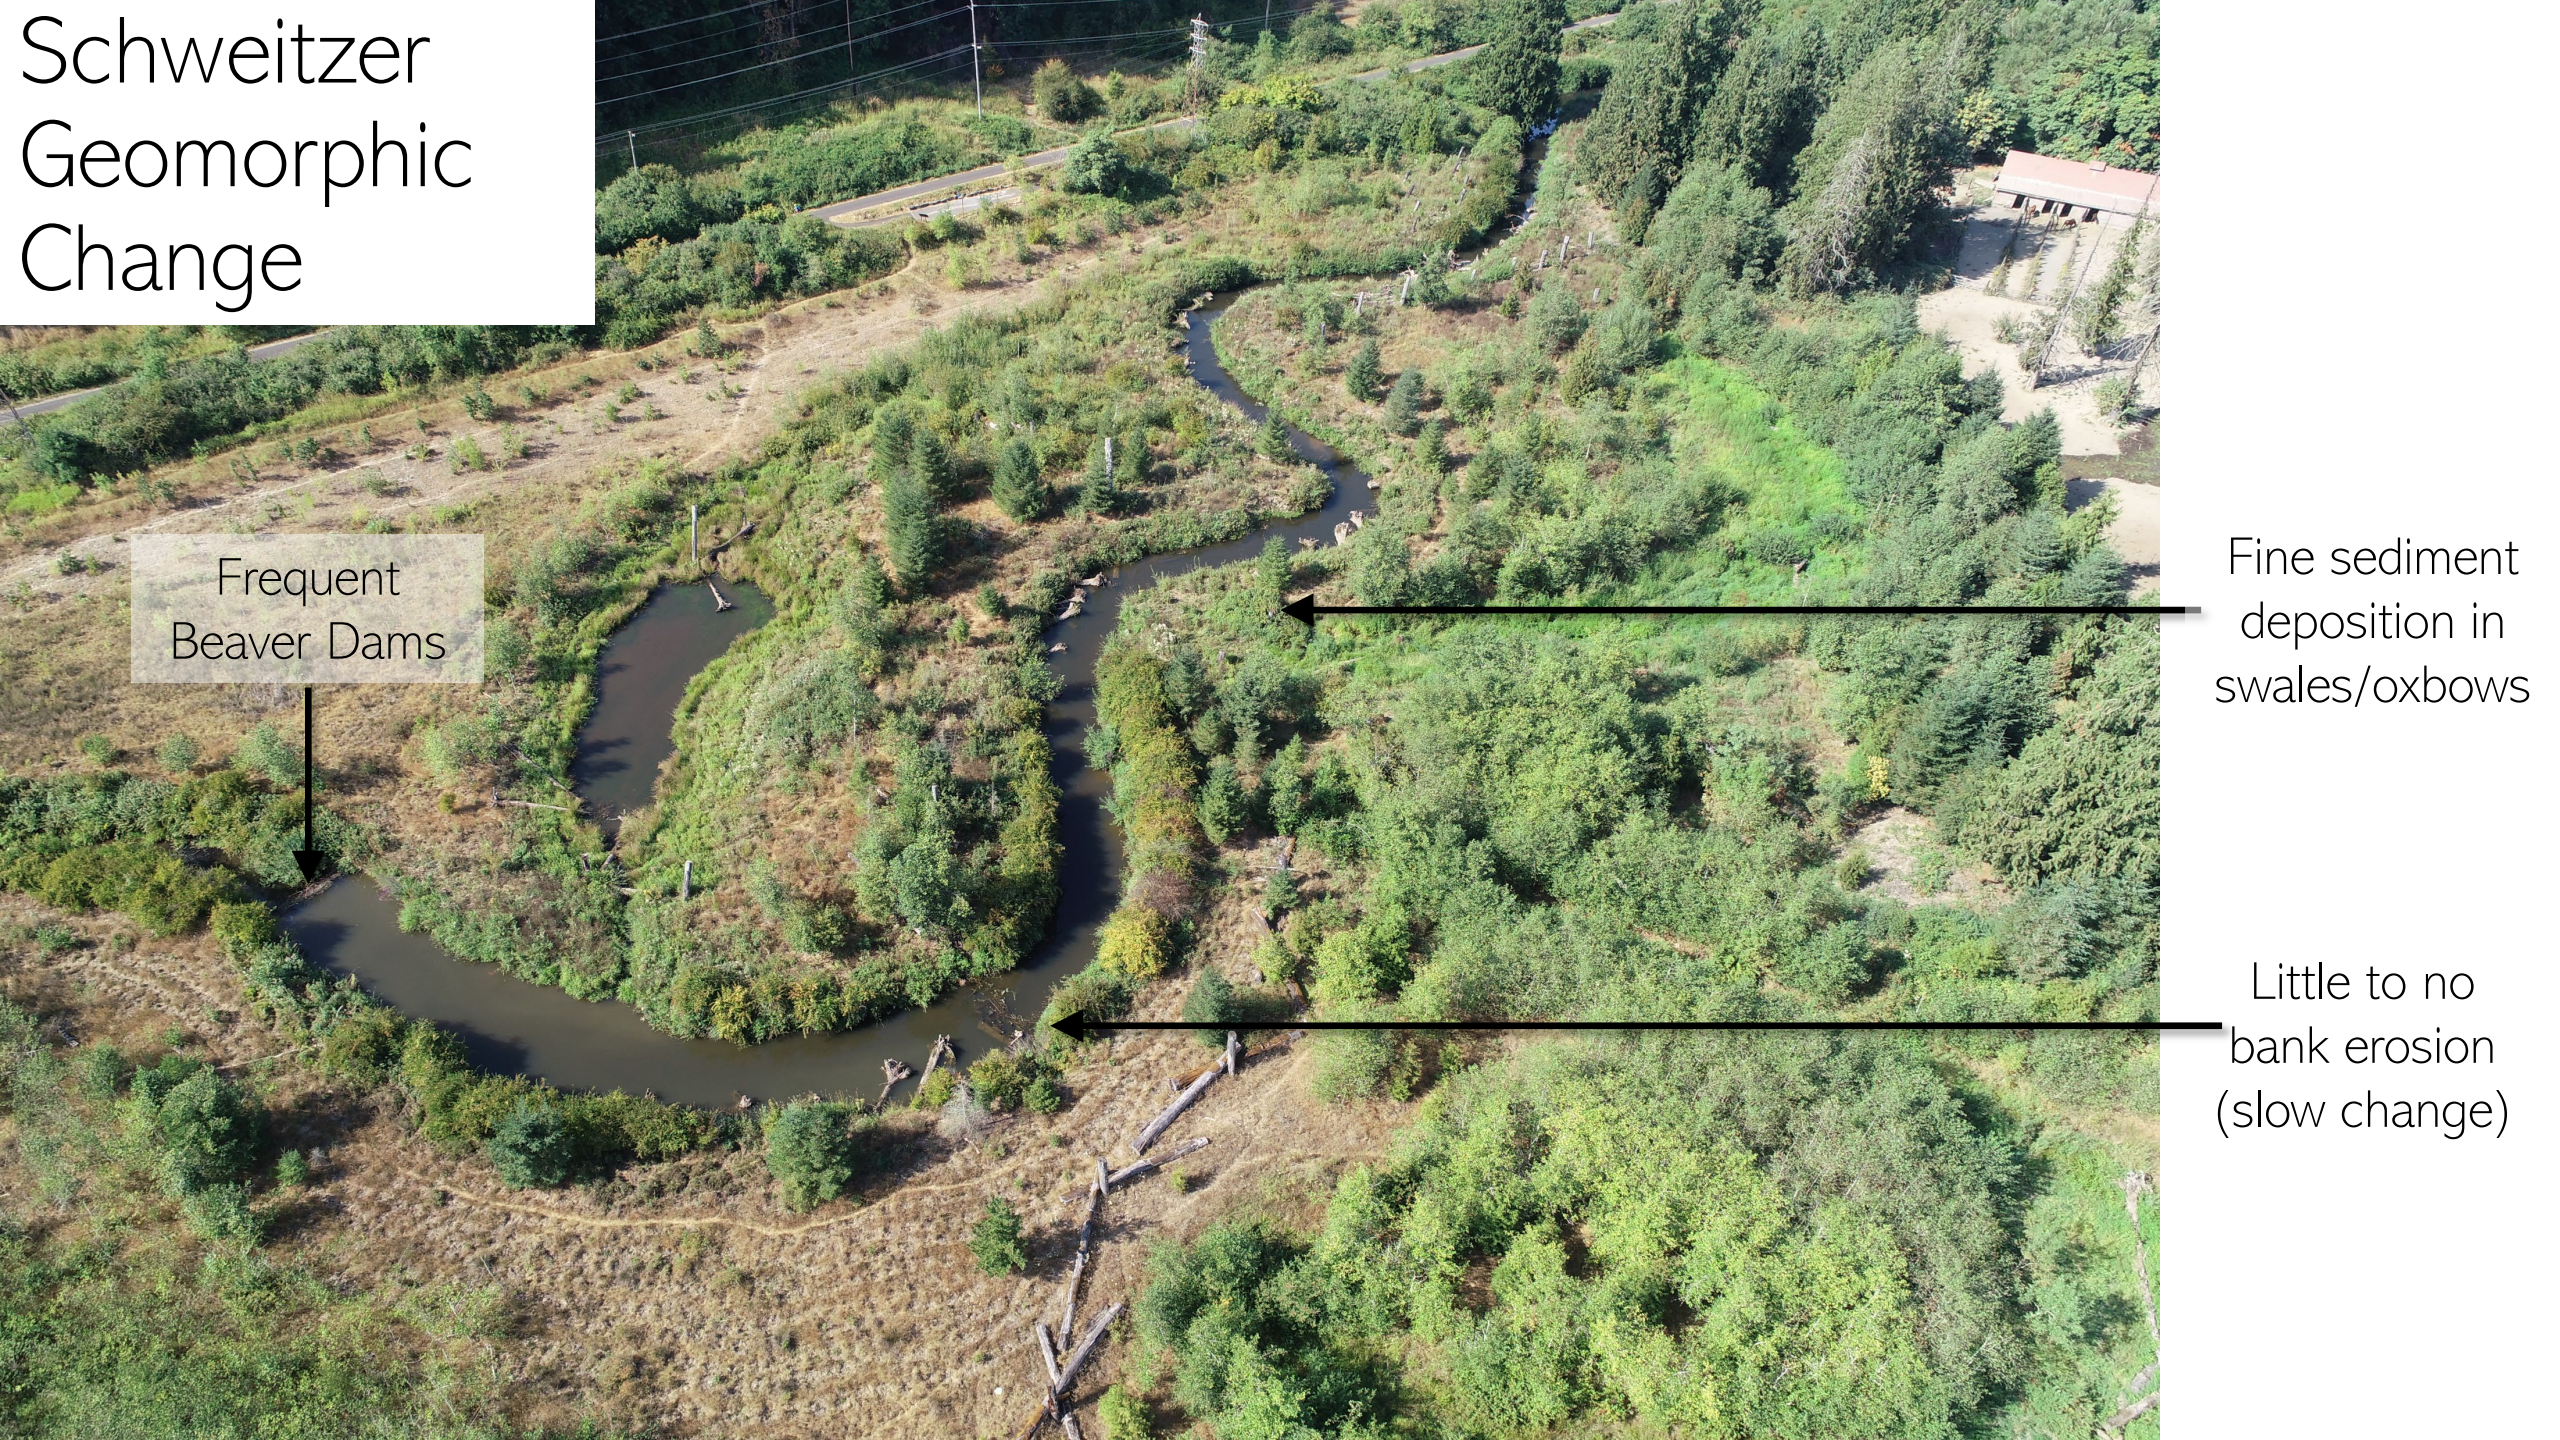
Schweitzer Geomorphic Change

Frequent
Beaver Dams

Fine sediment
deposition in
swales/oxbows

Little to no
bank erosion
(slow change)

Evolution of restored project reaches reflects the geologic history and stream energy environments
